Kootenai National Wildlife Refuge Habitat Management for Summer/Fall 2023

Overview

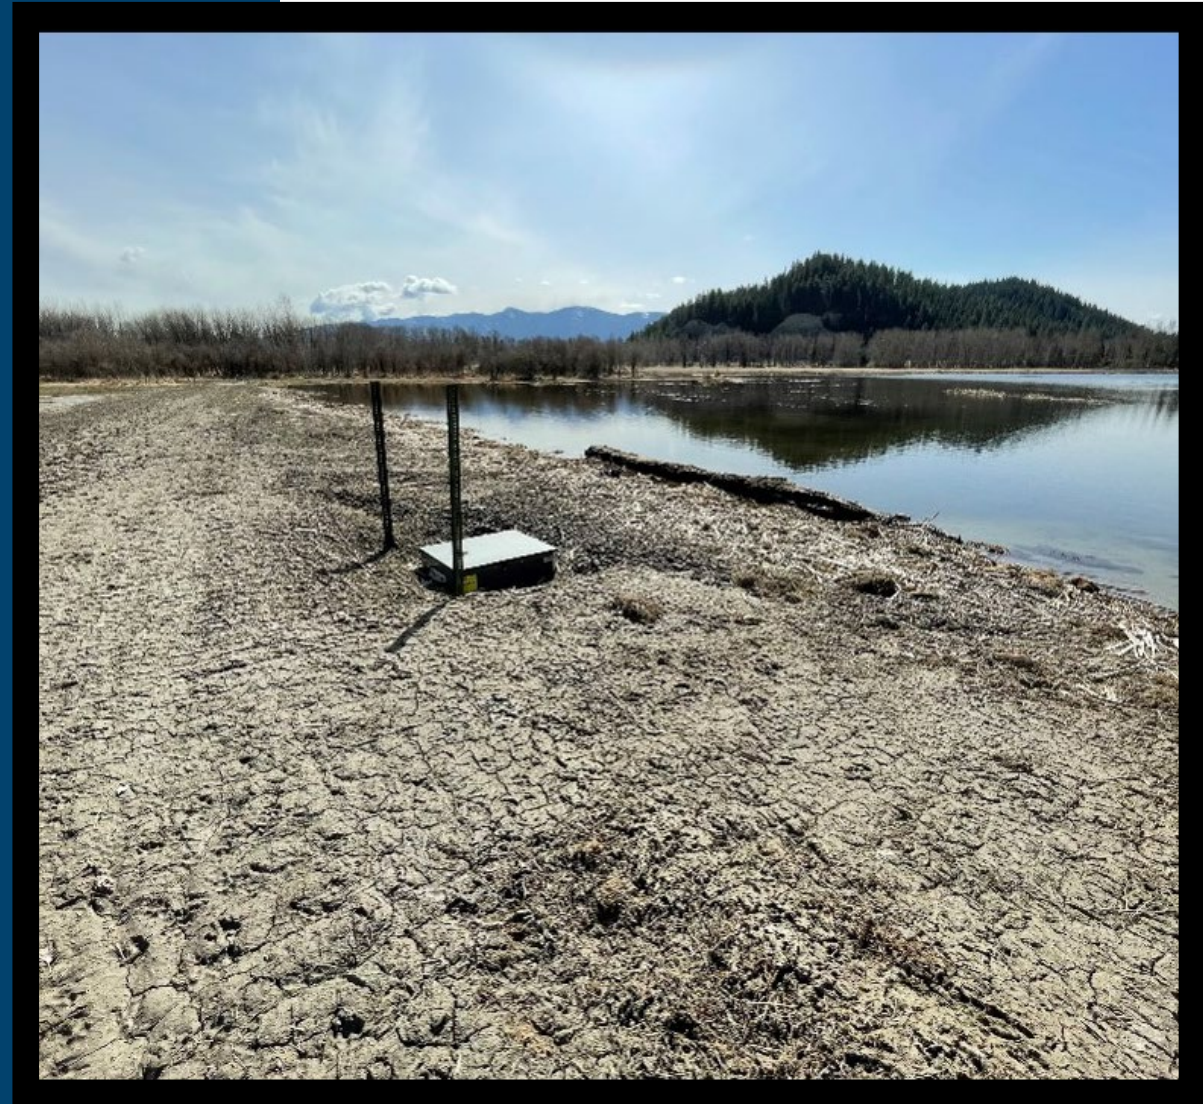
- Utilizing topographic features
- Low maintenance levee design
- Efficient water control structures

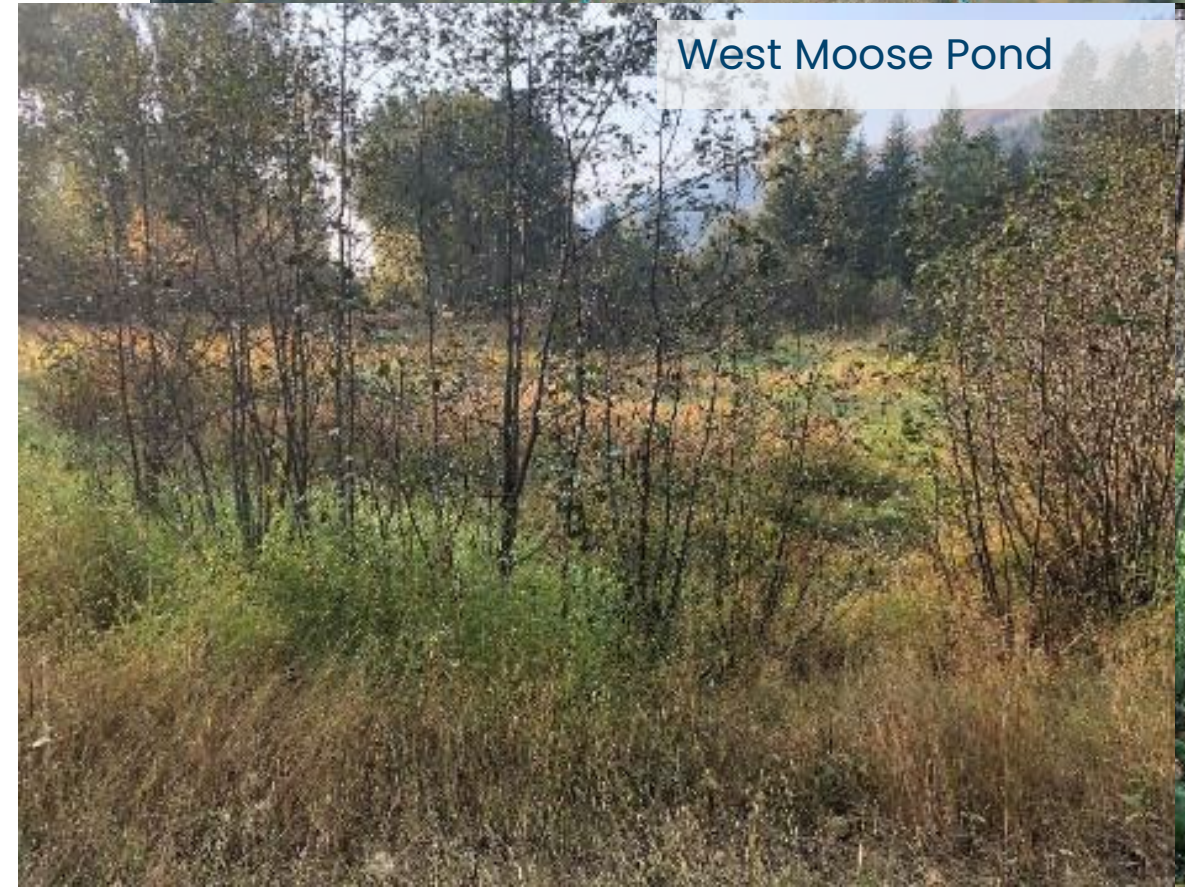
Existing Conditions & Limiting Factors

- **Cascade Creek alluvial fan below Westside Road.**
- Intermittent flows in Cascade Creek
- Decadent cedars-lack of regeneration
- **Damaged diversion structure-supplies water to Cascade & Cottonwood Ponds**
- **Berms around constructed ponds limit alluvial fan connectivity-West Moose Pond**

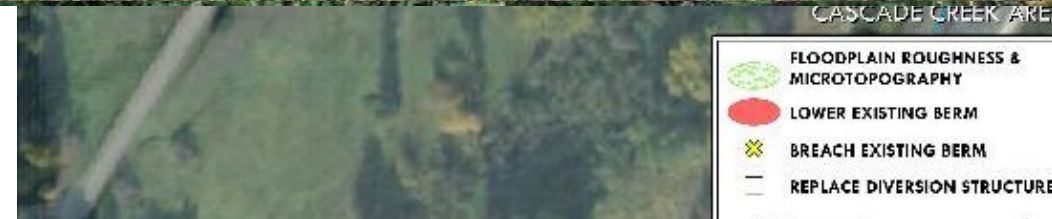
West Moose Pond

- CASCADE CREEK AREA
- FLOODPLAIN ROUGHNESS & MICROTOPOGRAPHY
 - LOWER EXISTING BERM
 - ✘ BREACH EXISTING BERM
 - REPLACE DIVERSION STRUCTURE

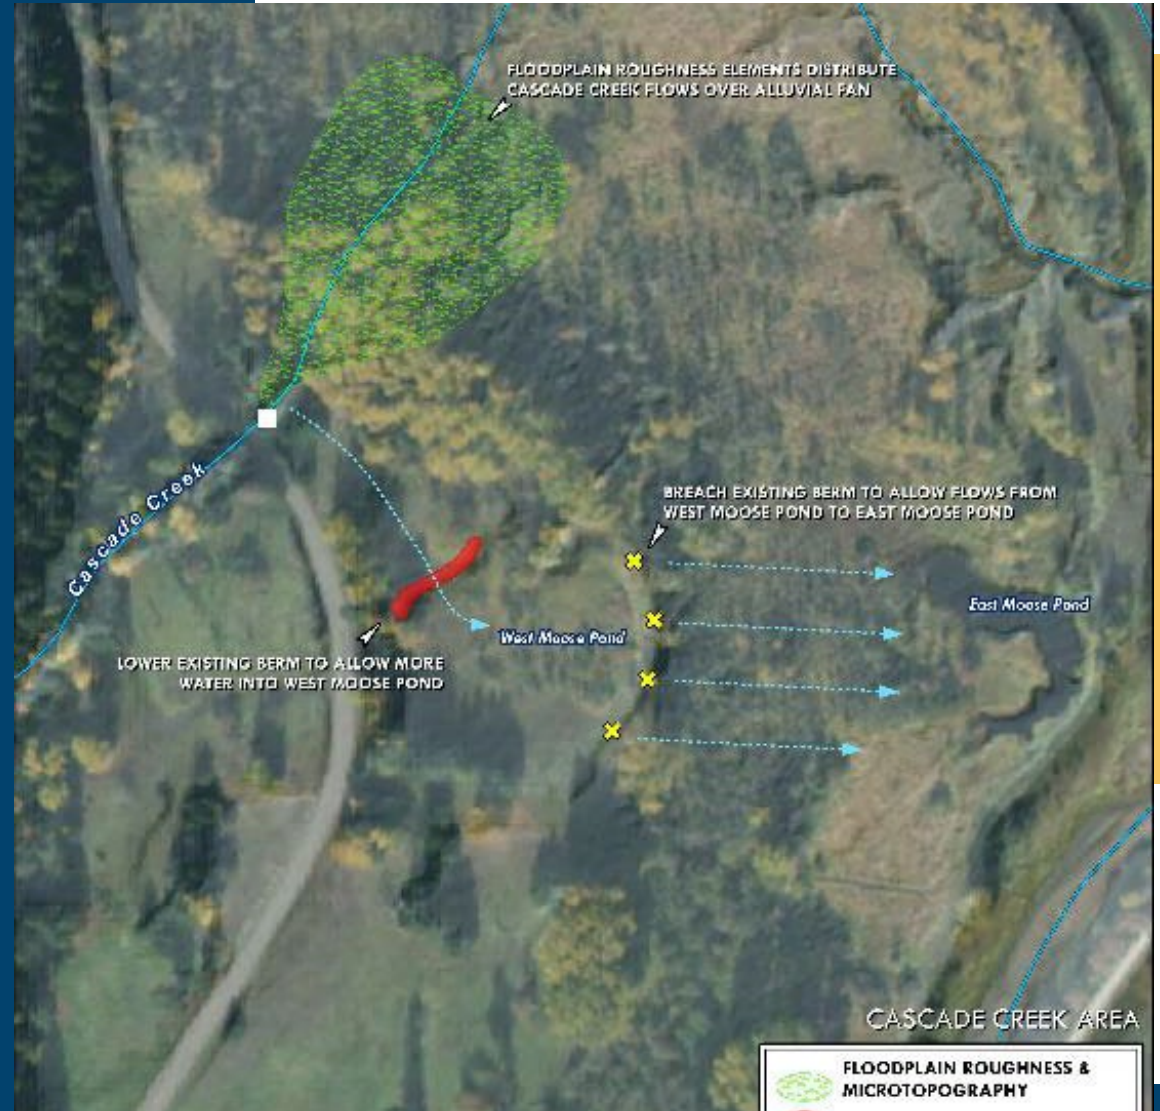
Proposed Actions

- Replace Cascade Crk. diversion structure
 - Allow for upstream fish passage
 - Egress to downstream ponds & Myrtle Creek
- Breech berms at West Moose Pond
 - Restore alluvial fan connectivity
- Place large wood pieces in floodplain
 - Trap additional debris & promote alluvial fan processes

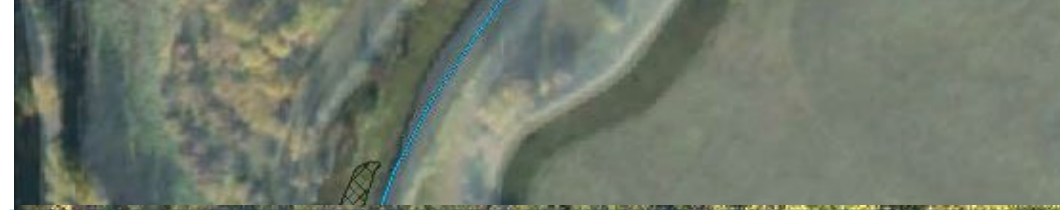
East berm of Cascade Pond

- Constructed Pond
- Receives water from Cascade creek diversion
- Drains north to Cottonwood Pond & south to Cascade Creek
- Limited woody vegetation due to dense RCG
- Harmful algal bloom in 2021

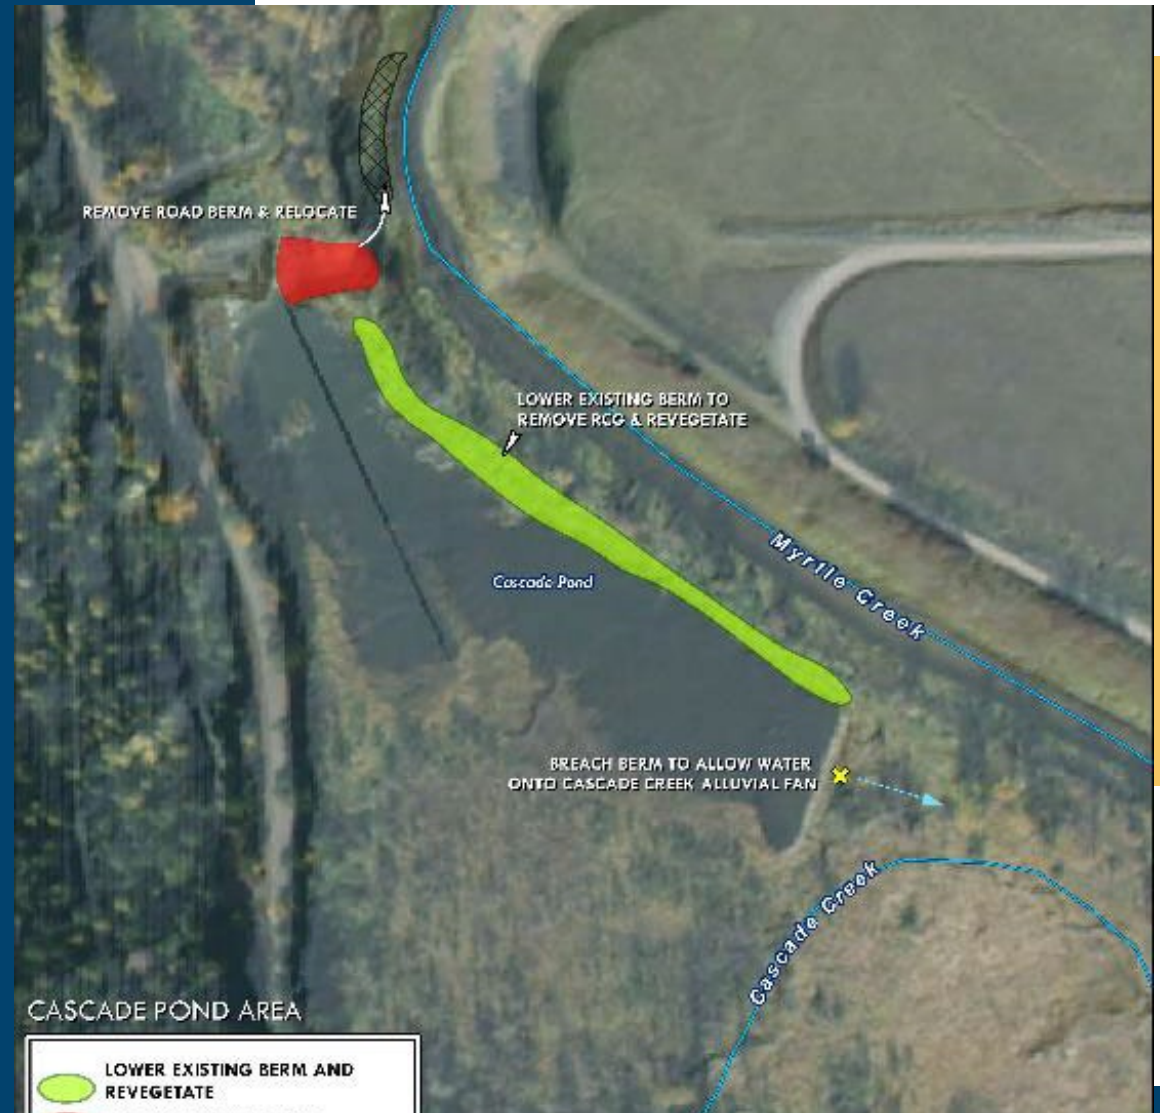
Proposed Actions

- Lower berms & bridge approach fill area
- Create conditions to support woody vegetation around pond
- Maintain north outlet elevation to support wetlands
- Remove RCG on berms, plant trees & shrubs to restore woody vegetation
- Plant with dense brush to deter browse

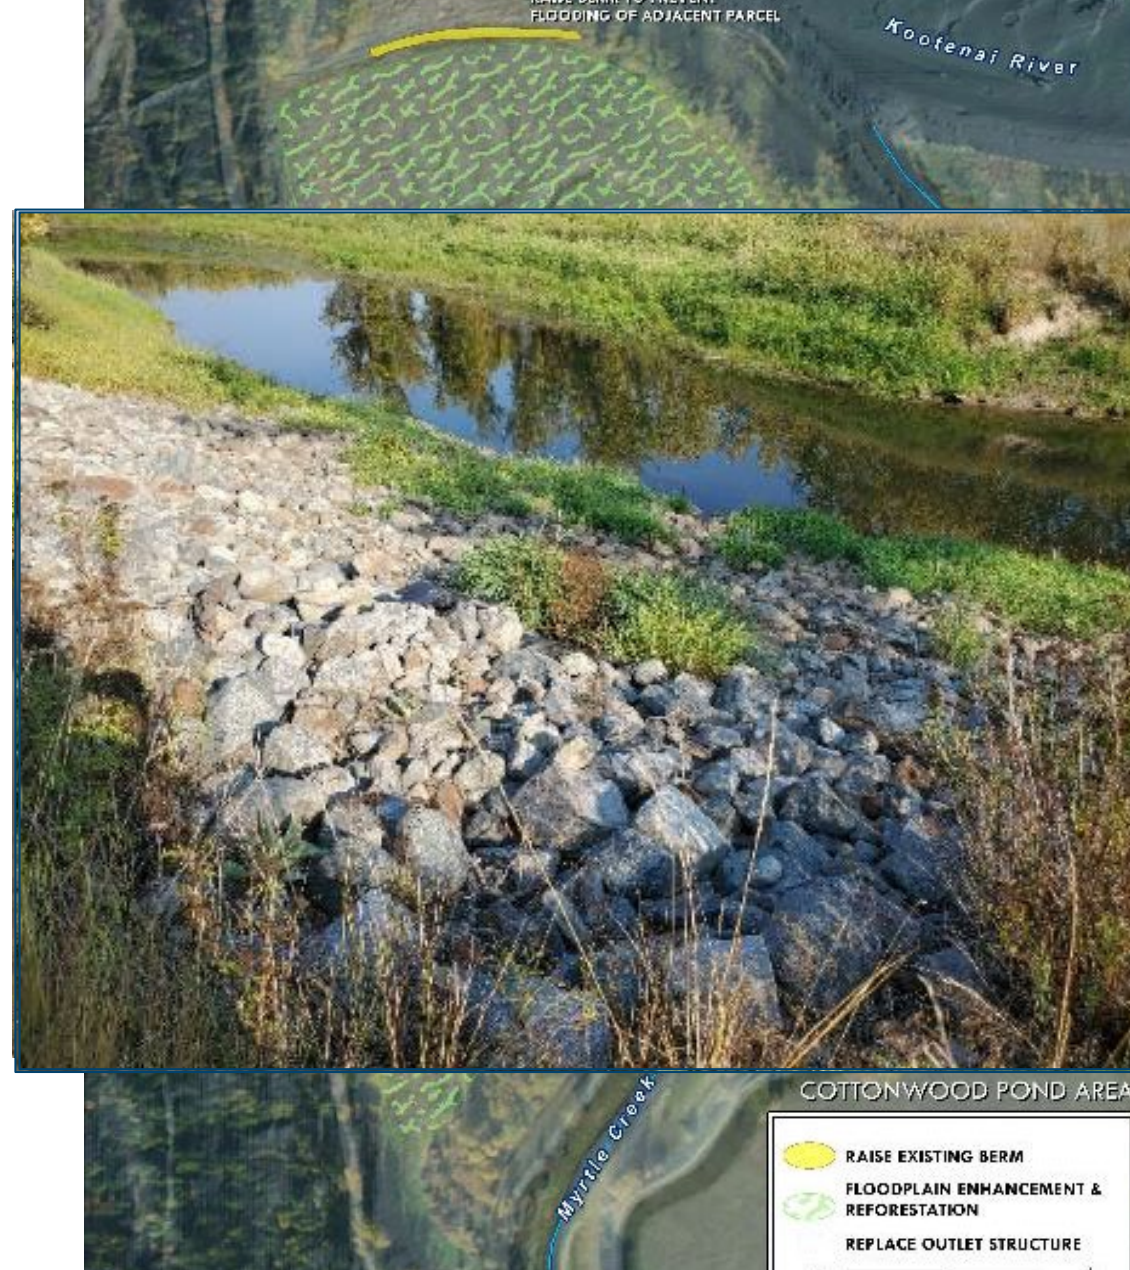
Existing Conditions & Limiting Factors

- **Constructed pond with water control structure at outlet**
- Water supply from Cascade Pond & groundwater
- **Kootenai River backwater present**
- **Drains to Myrtle Creek via outlet structure**
- **Low berm on north side of pond**
- **Cottonwood, alder, & others around edges of pond; bullrush, RCG in pond**

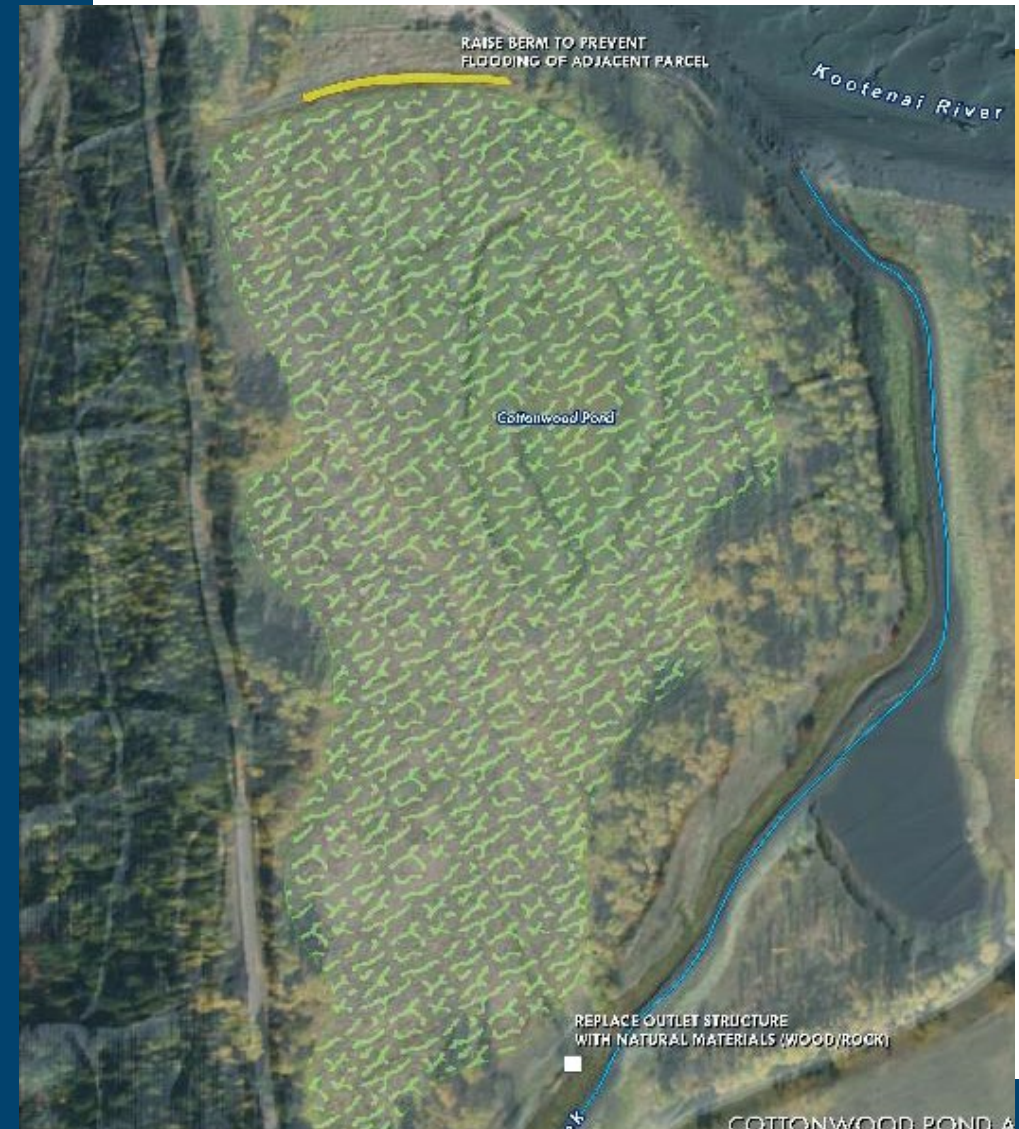
Proposed Actions

- **Replace outlet with natural channel to Myrtle Creek**
- Large wood in outlet channel for stability
- **Lower water surface elevation will promote restoration of woody wetland vegetation**
- **Raise berm on north end of pond with material excavation at other sites**

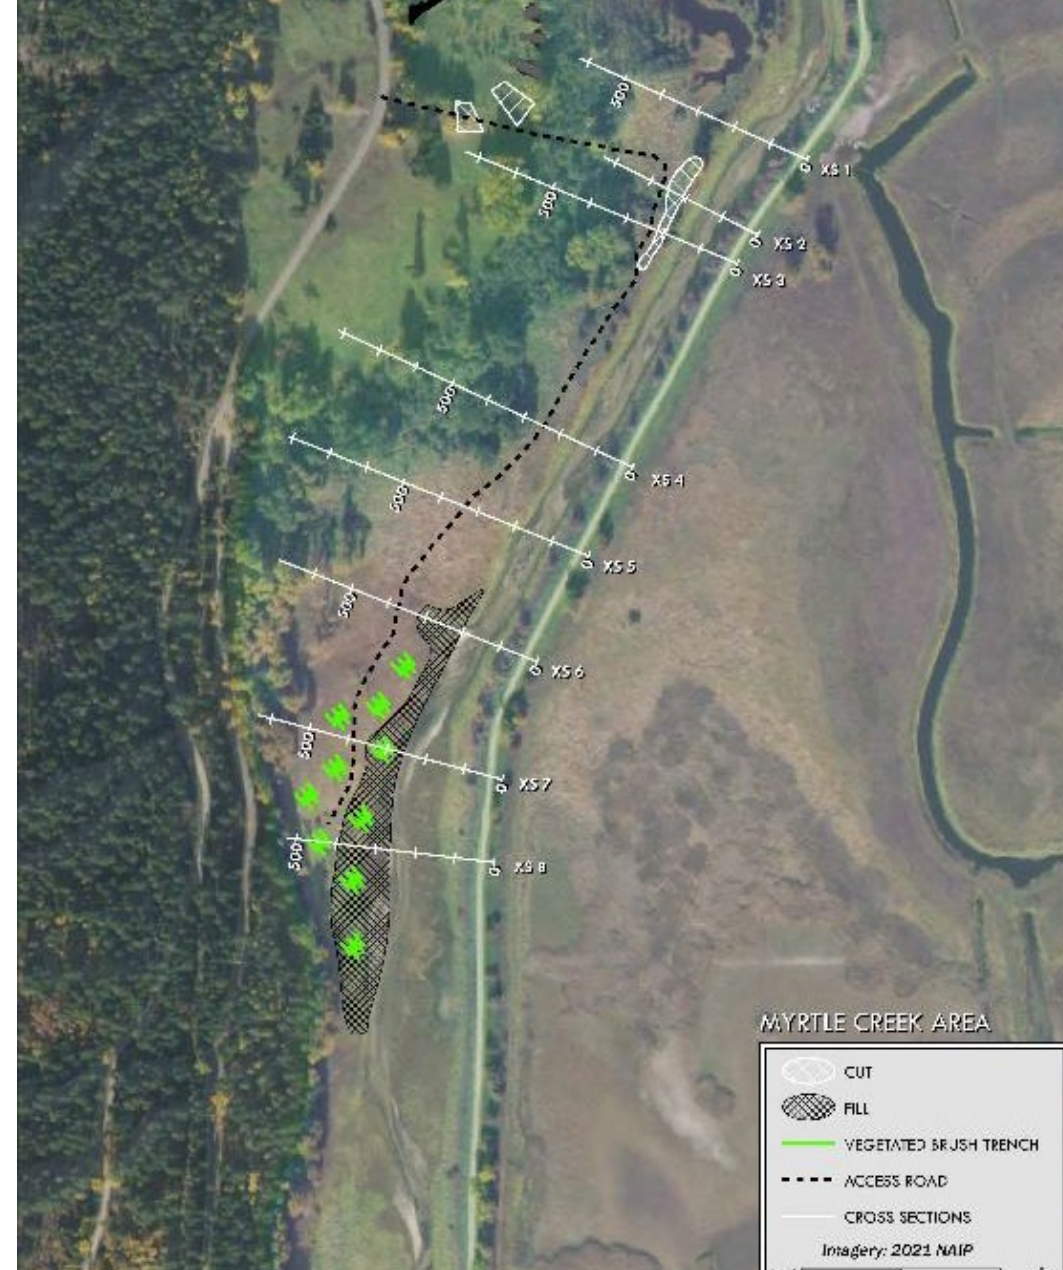
Existing Conditions & Limiting Factors

- Lower reaches of Myrtle Creek
- South, upstream of Cascade Creek mouth
- Kootenai River backwater present
- Auto-tour route levee on east side of creek
- RCG dominated floodplain

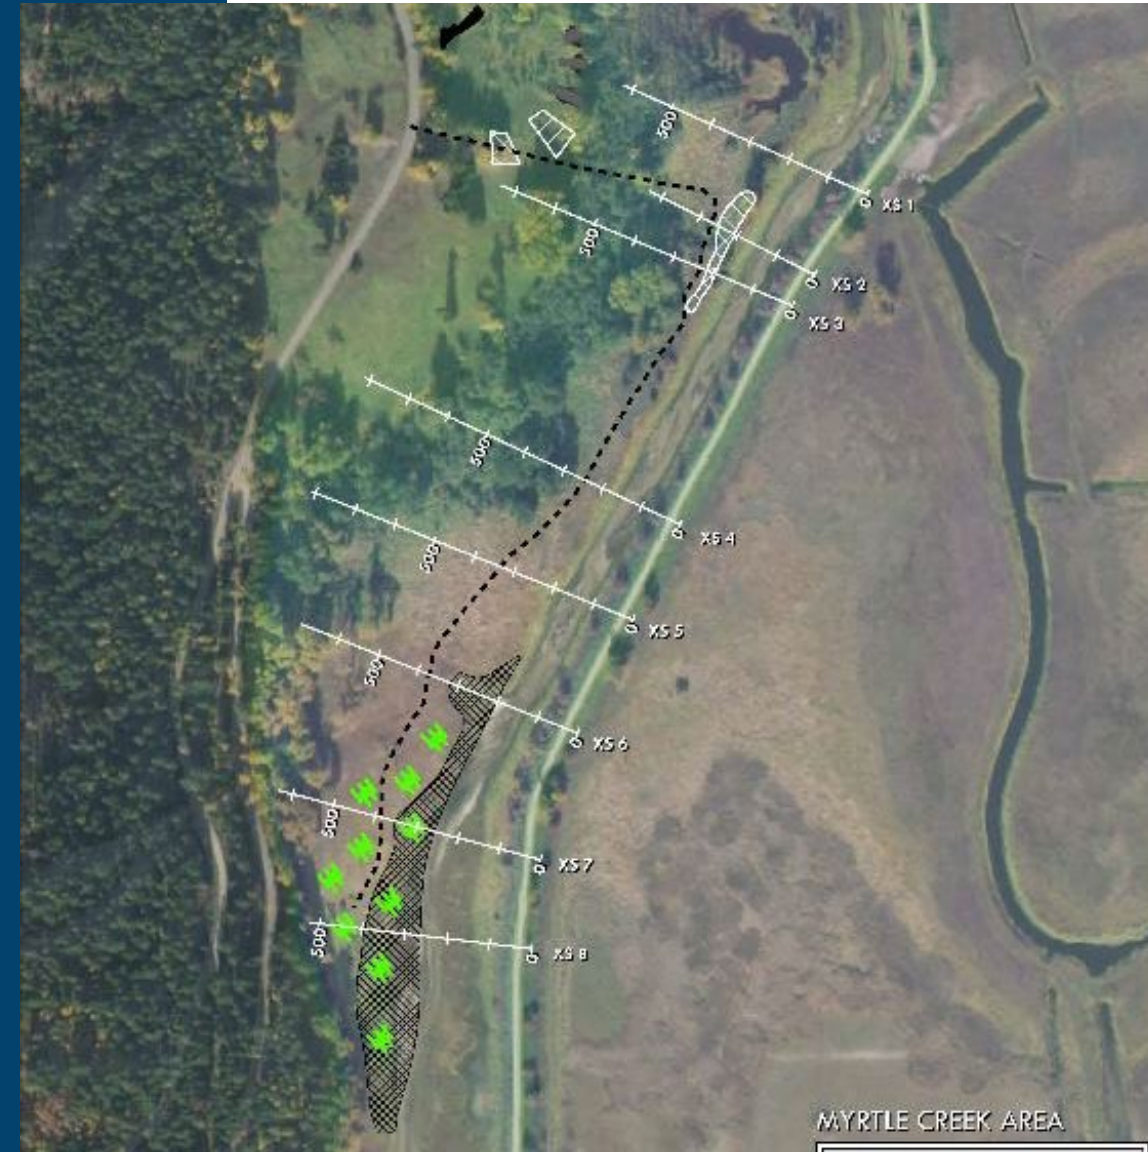
Proposed actions

- Selectively remove RCG to create conditions for woody vegetation re-establishment
- Place excess material along Myrtle Creek & plant with brush
- Consider a seasonal side channel on west side of creek
